Fermilab PIP Booster Accelerator RF Cavity Refurbishment

ARW 2015

27 April 2015

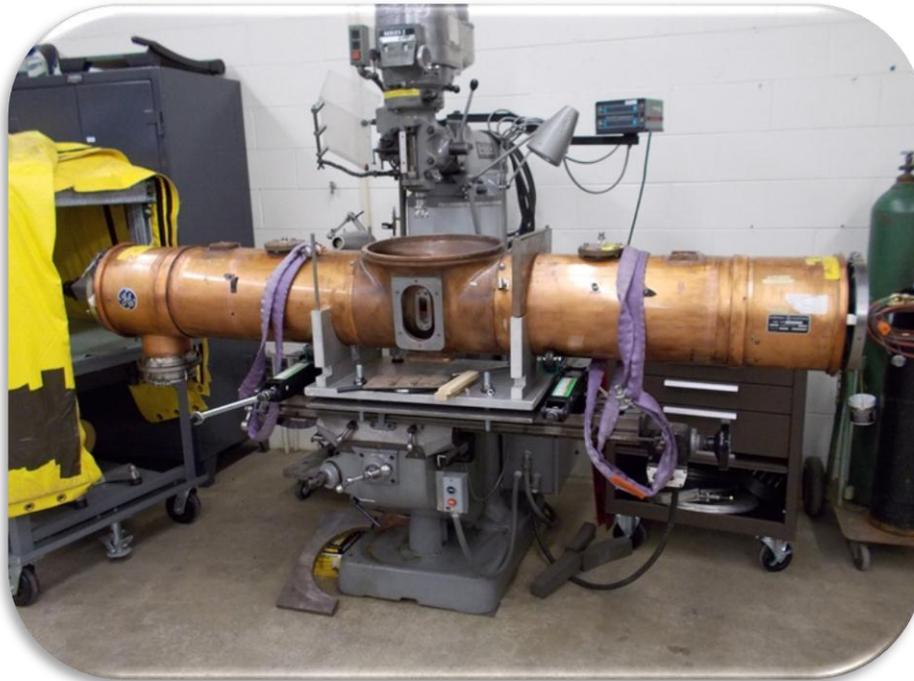
Milling improved quality,
reduced time and distance
(dose). ~ 7 days → 2 days

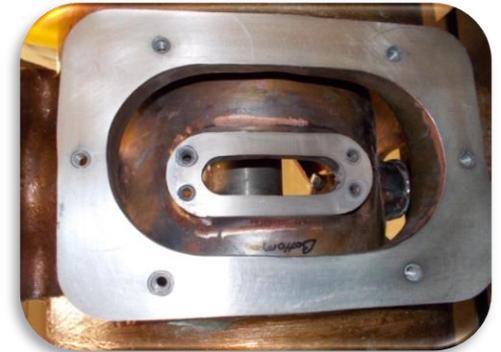
Insufficient
contact
= heat and
RF leakage

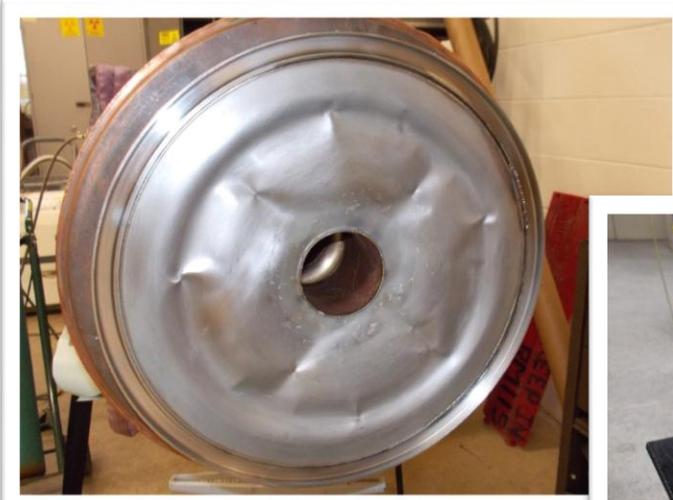
Leaking “pie-tin” quick disconnect flange

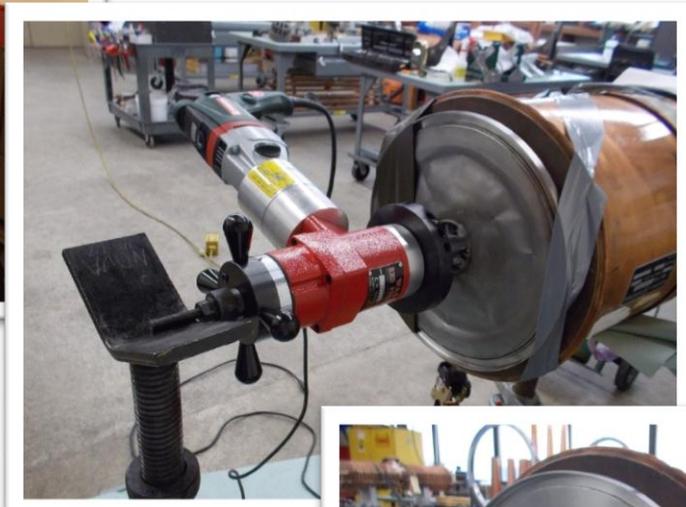
Removal with Wach’s tool

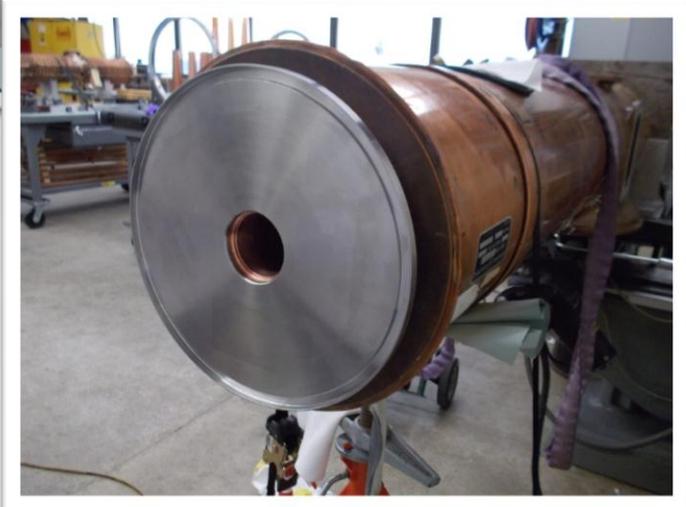
Replace with solid flange

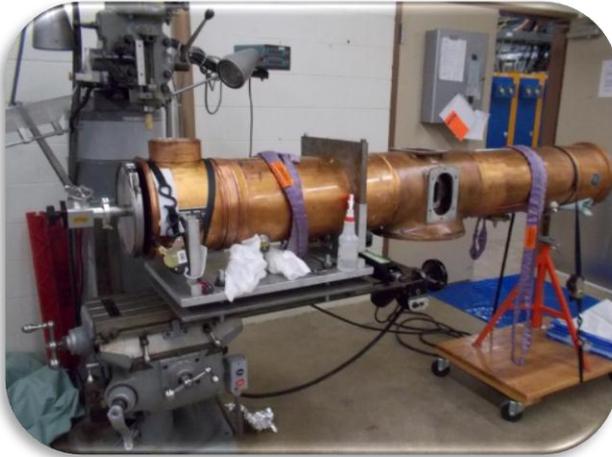
Improved repair tooling

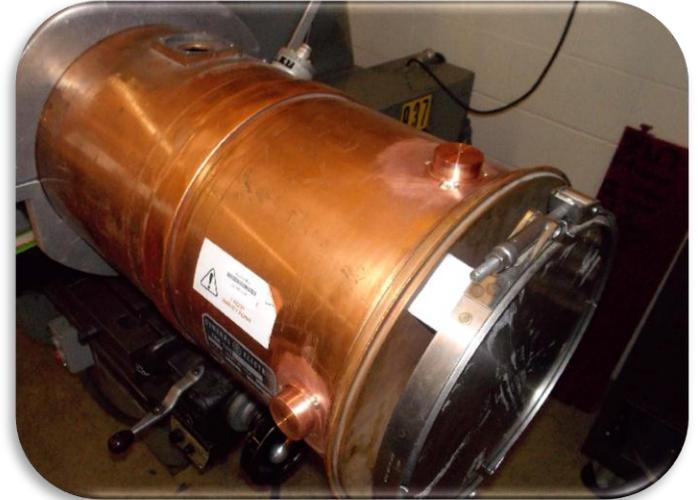
Alignment fiducials installed

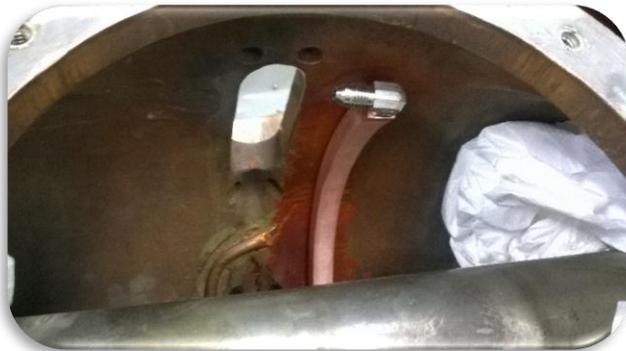
Water cooling repair/upgrade

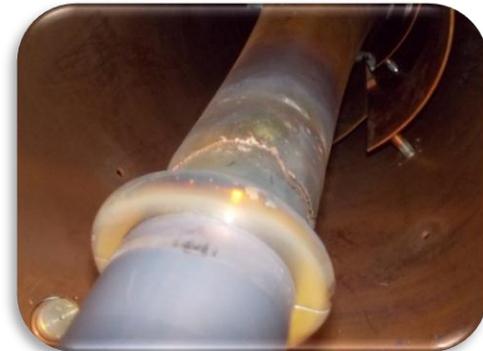
Internal sparking and damage

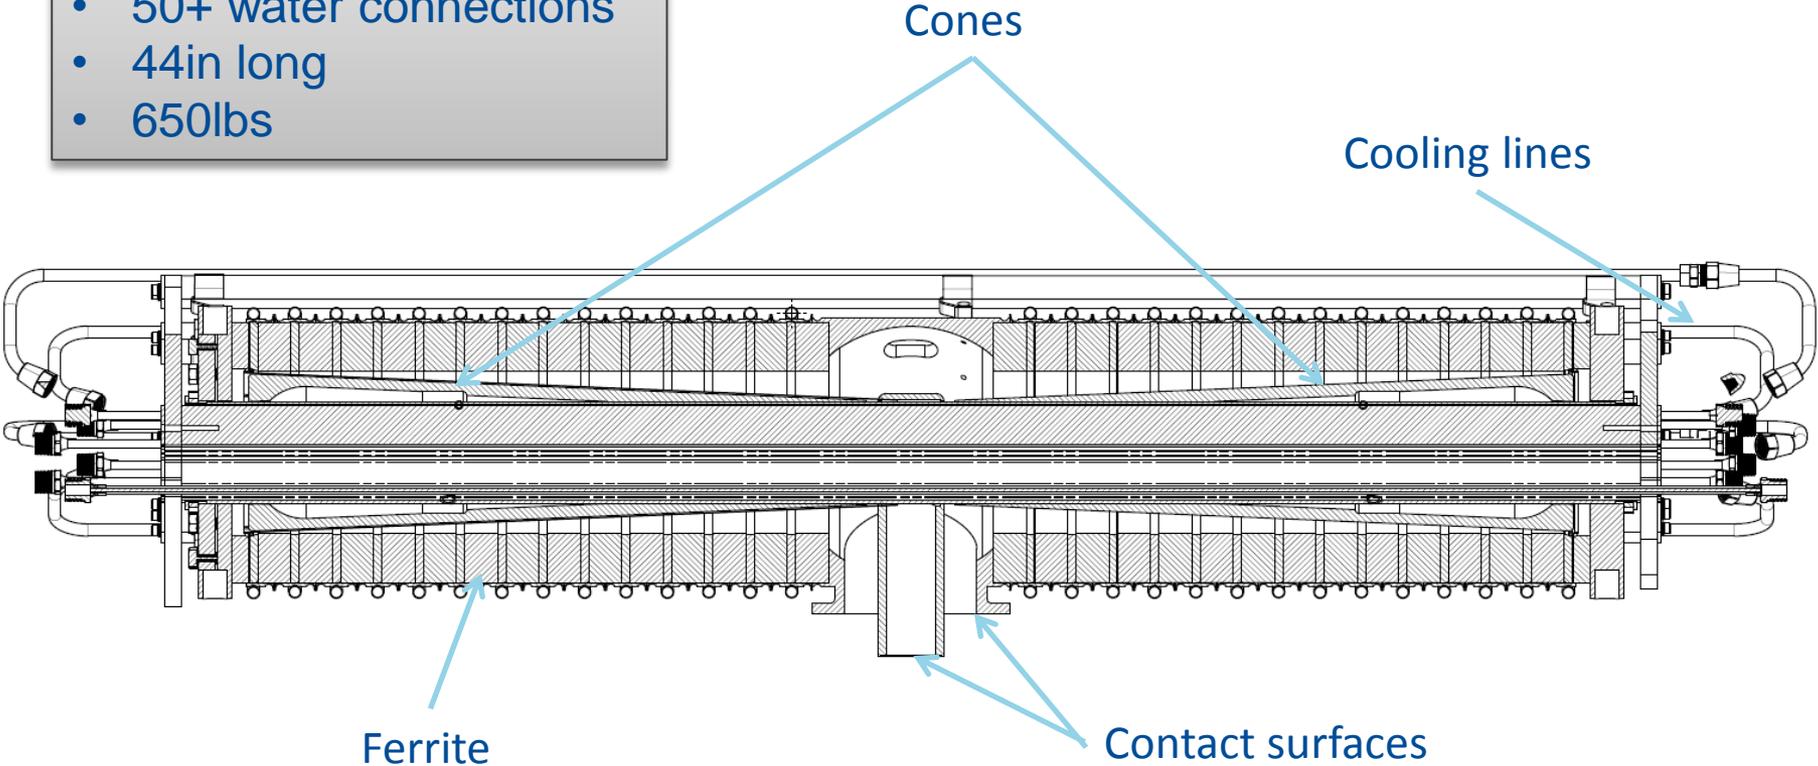
Each tuner:

- 500+ pieces
- 150ft+ tubing
- 50+ water connections
- 44in long
- 650lbs

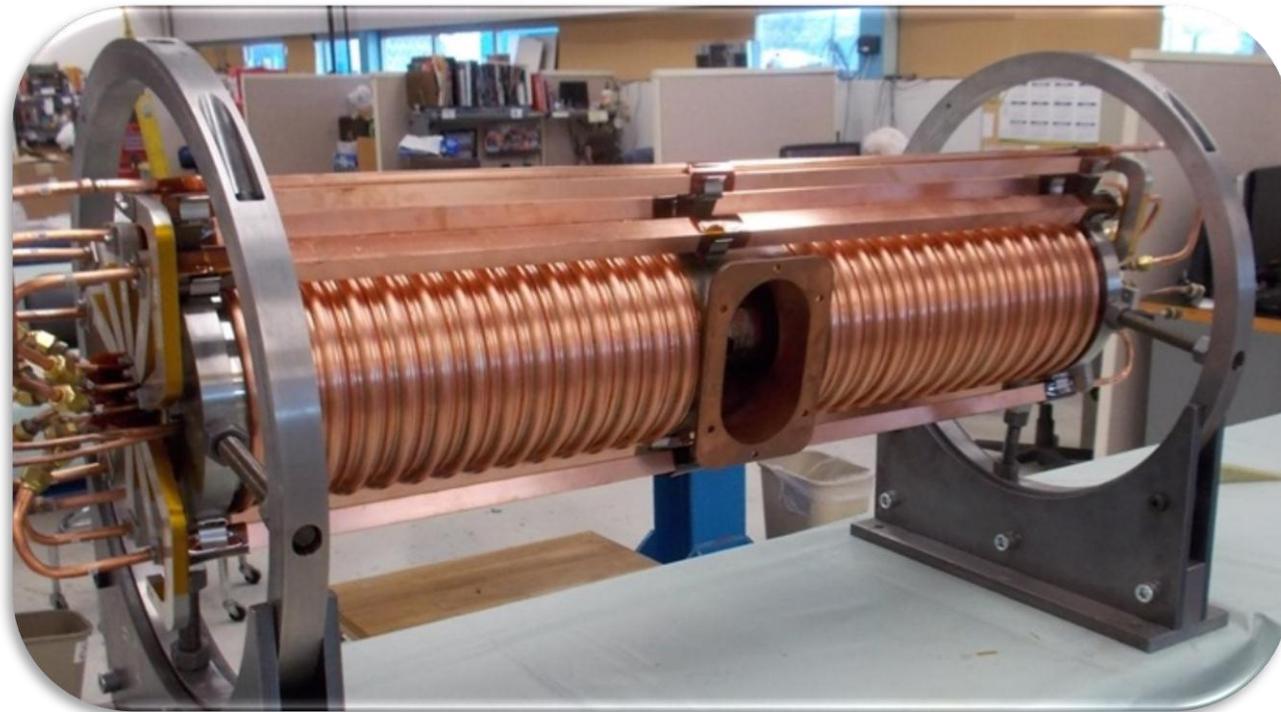
- Have begun building new tuner assemblies
- Potentially replace all refurbished tuners with new
