Subject: Proton Improvement Plan

Project Quarterly Summary FY16 Q1

Report #13 January 14, 2016

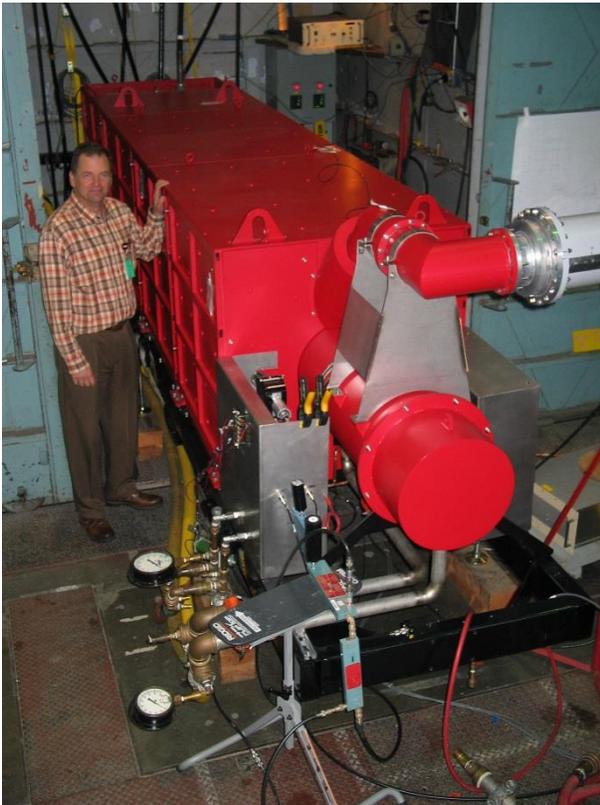
Figure 1. VKP8201A- S/N 001 positioned at CPI test stand.

The klystron prototype development reached its completion. A new klystron (type CPI VKP-8201A serial no. 001) was successfully tested to **most of the agreed** contractual standards. During test the tube produced 5.04 MW peak RF output power at a frequency of 201.25 MHz with a corresponding gain of 36.6 dB and an efficiency of 43%. A team from Fermilab composed of the PIP Project Manager and Proton Source Department Head, William Pellico, AD RF Engineer, Alfred Moretti and PIP L2/L3 Manager for the 200 MHz system and Linac group leader, Fernanda G. Garcia visited CPI for klystron inspection and witness the acceptance test. Prior the test, a round table discussion on the manufacture process and future plans for both CPI and Fermilab took place. Some important points were raised such as the company inquired about the possibility of Fermilab initiate the upgrade, therefore, going for production mode. PIP Project Manager re-iterated the position that at this point PIP will not go ahead with the upgrade plan for this system based on the direction of the laboratory in building a new super-conducting linac (PIP-II project). Nevertheless, the successful demonstration of the 200 MHz single-beam klystron is seen as a promising device technology option to provide a continuity to the operations of the Fermilab room-temperature linac if the laboratory finds that a multi-year delay on the construction of PIP-II linac is possible. Along these lines Fermilab asked for a revised manufacturing cost estimate from the leading engineers and businessman so that PIP can update its planning schedule/cost for this upgrade.

Synopsis of the Acceptance Test -- The klystron had stable operation and was able to achieve full output power but the efficiency and gain were lower than expected. Additionally, the input drive to output power transfer curve had an irregularity in the linear region. The curve was within the specification limits, but additional tuning was performed to minimize the magnitude of the irregularity. During the testing period it was found that some of the type-n coaxial adapters in the output metering line did not have an adequate bandwidth response and that the bandwidth measurements were incorrect. This was validated by comparing steady-state calorimetric power levels to those measured through the power meter. After replacing the parts at fault CPI was able to establish consistent power measurements between methods. Based on the new bandwidth, CPI decided to re-tune the klystron and continue testing into January. Re-tuning the tube improved the gain, but it was still under the specification. As the last test, an x-ray survey, was about to be completed one of the high power coaxial loads started to arc at low powers. It was found that an internal water joint was corroded and an electrical connection was faulty. After rebuilding the load the final tests were completed January 15th. Pending acceptance of the test data by FNAL the klystron will be shipped in the end of January.

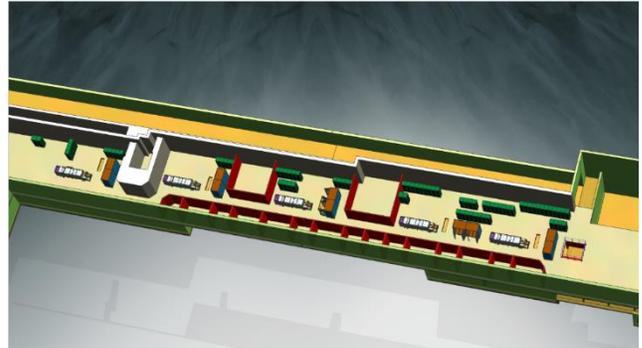
Figure 2. Linac north gallery floorplan showing a possible position for the new 200 MHz klystron.

At Fermilab efforts continue on drafting of the linac north gallery floorplan layout. In addition a final document report on this system is in progress.

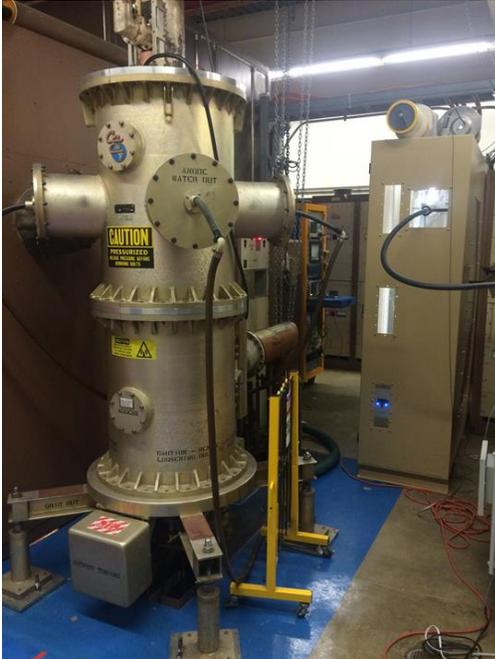
Figure 3: Linac Marx-Modulator cabinet positioned by FPA at Linac LRF1 station.

The 28 cell prototype modulator was tested into a dummy load and then moved to the Linac gallery where it was connected to the 7835 at LRF1. The modulator was successfully operated to the required voltage and current to operate the 7835 at nominal gradient. In addition, beam was successfully accelerated to the end of Linac despite the incomplete controls available at the time of the test -- limited feedback and

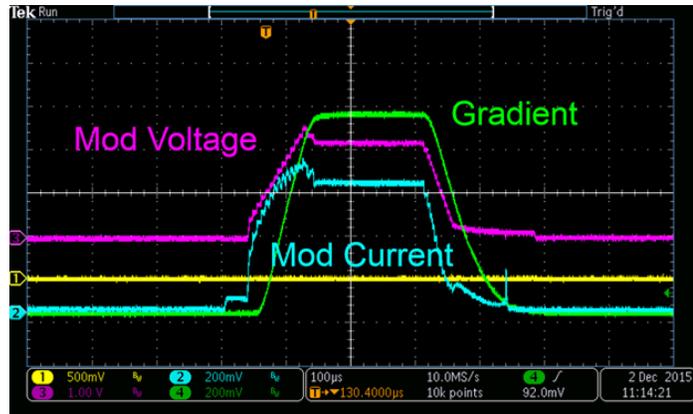
Figure 4: Linac Marx-Modulator wave form while driving the LRF1 station.

no compensation for beam loading. Nevertheless, the test was a success and revealed various control and interlock issues which have been worked on at the end of the quarter.

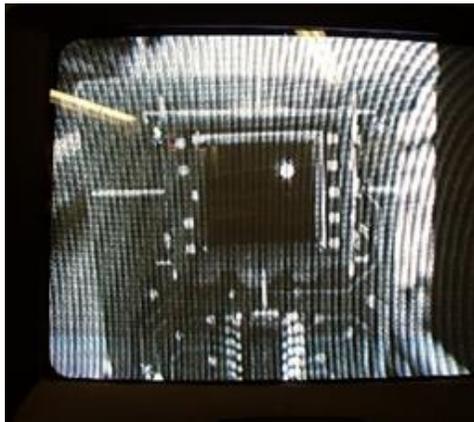
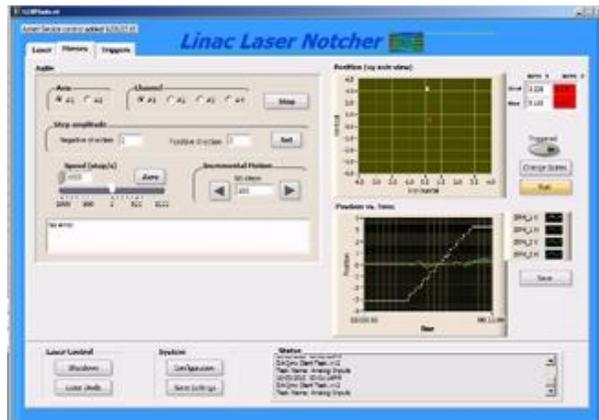
Figure 5. Video image of the laser on the OBPM and the OBPM response from the piezoelectric mirror vertical movement.

In addition to solving the connector issue, numerous other tasks were accomplished. The laser system safety interlock module was installed in the laser electronics rack and is used to provide permits for all lasers and amplifiers. The Safety System Critical Device Controller module was installed in the RFQ Injector Line (RIL) control Room and cables pulled to the location of the notcher system next to the RFQ. We developed an optical BPM system (OBPM) when coupled with our piezoelectric launch mirrors will allow us to steer the IR laser beam into the optical cavity with a few micron accuracy.

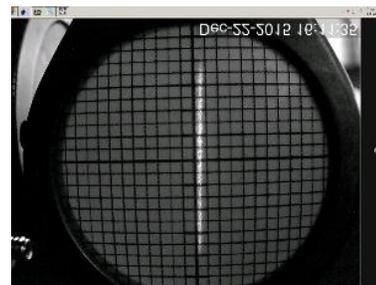
Figure 6. Image of IR laser beam out of the optics box [1 mm grid]

A real time USB video monitoring system was developed to monitor the IR beam position and transverse profile in the optics box, transport enclosure, and laser dump enclosure (Fig. 6)

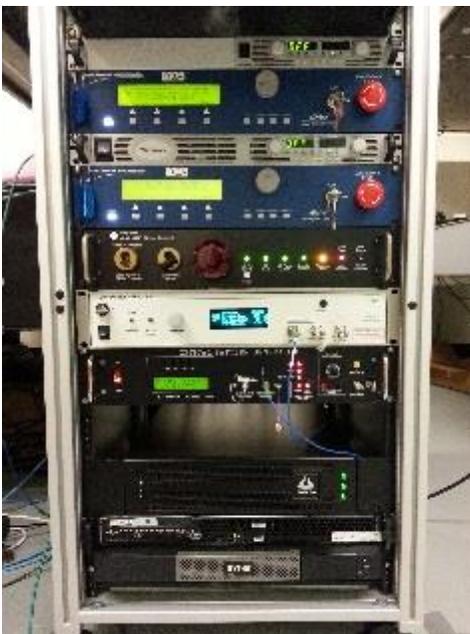
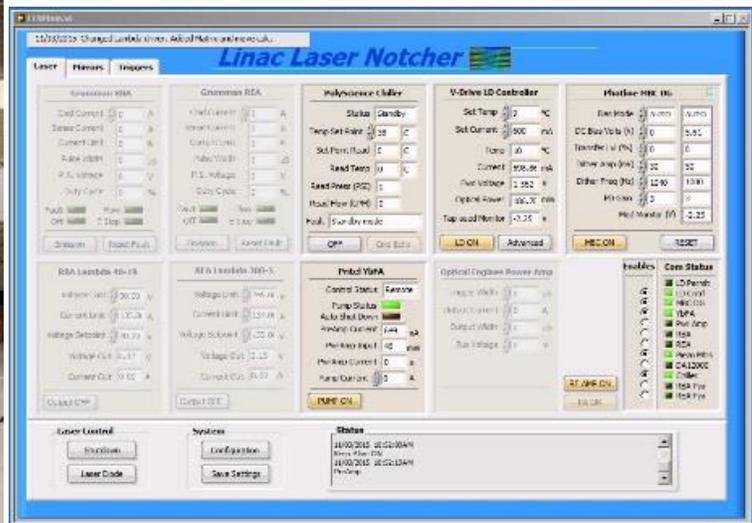
Figure 7: The electronics rack and control program talking to several of the devices

The transport and dump enclosure designs were finalized and manufacturing prints were delivered to the shop. The controls software used for the control of the complete laser system continued to be upgraded and debugged (Fig. 7)
