Subject: Proton Improvement Plan

Project Quarterly Summary FY15 Q2

Report #10 April 17, 2015

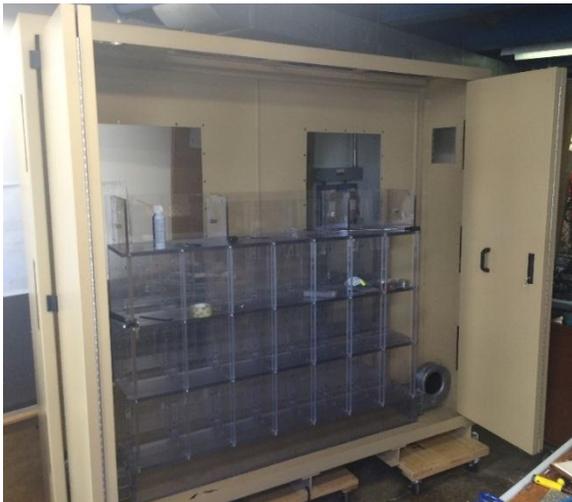
Figure 1 Linac Marx modulator being assembled

AD/EE Support Design: Work is progressing well on developing a prototype modulator capable of replacing the present tube based design. During this quarter the all 7 control cards design was finalized. More manpower was added to the project to aid the assembly of the control cards to be used on the 28 cell version. High voltage testing on the cells were performed and results revealed important and necessary

modifications on the cell backplane structure and the bracket assembly. All these modification have already being incorporated into the design. See figure 1 below of new Linac modulator being assembled.

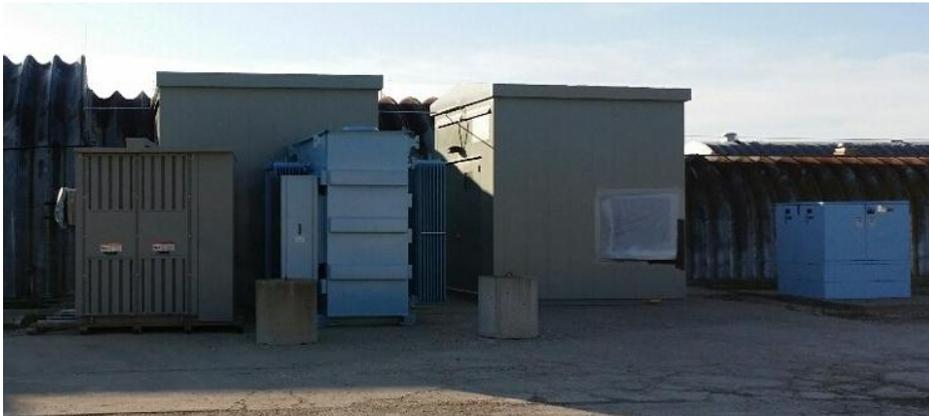
Figure 2 The two Booster anodes (large grey boxes) and testing gear

Parts for the anode supplies have been received. Sub-assemblies are being constructed and tested. Final assembly will occur in FY15Q3 with testing to follow. During the 2015 shutdown, the anode supplies will be installed.
