Subject: Proton Improvement Plan

Project Quarterly Summary FY15 Q4

Report #12 October 22, 2015

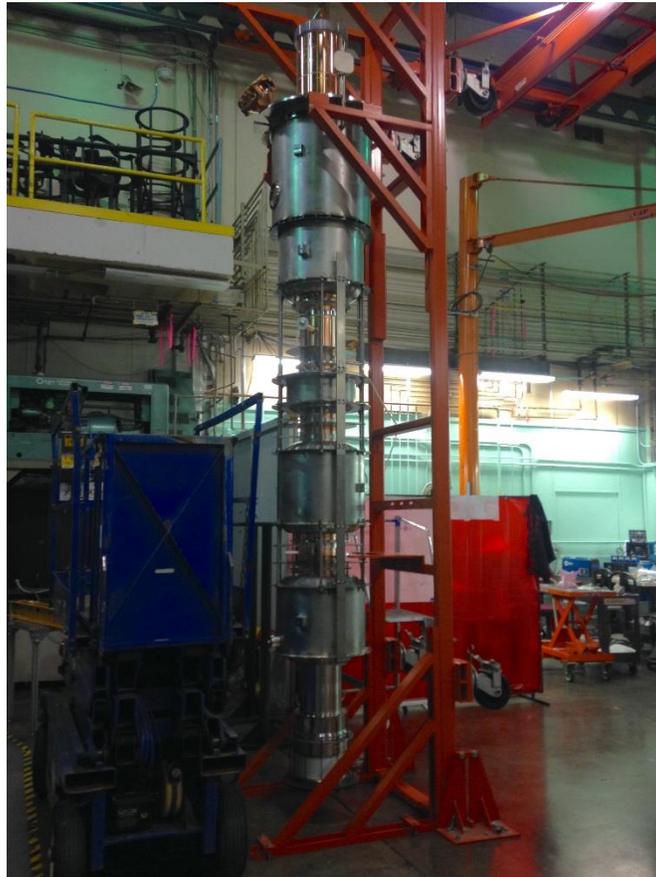
Figure 1. Klystron fully assembled getting ready for bake-out.

Klystron manufacturer -- The 1st cavity assembly frequency and loop geometry were finalized. It is waiting to be brazed before the final cold test and weld. The 2nd cavity and 3rd cavity have been finalized and welded. The braze of the wall that joins the 4th and 5th cavities, which was previously reported they had failed, has been completed and passed the vacuum leak check successfully. With that cold testing of the 4th and 5th cavities was complete. The output loop needed more adjustment than expected. CPI had originally purchased 3 different sized loops, but the final dimensions were beyond any of the three loops purchased. A method of separating the solid loop and then re-brazing it as one piece was developed and worked out well. The output cavity wall has been assembled and is currently going through the braze furnace. This output wall is similar to the other wall which required additional rib supports and a new heat shield to be used during the braze. This braze went very smoothly with the added experience of the previous wall as well as the fact that this wall is significantly thicker and more robust. At the time of this report, the team was getting ready to start the bake out. Figure 1 shows the klystron fully assembled.

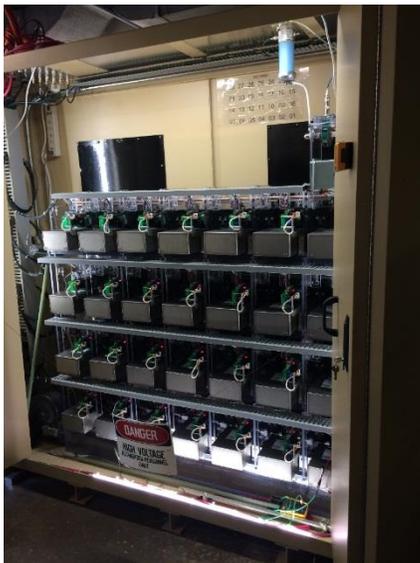
Figure 2: Linac Marx-Modulator Cabinet showing cell shelving units and all rows populate with 28 cells.

A total of 35 cells were fully assembled, tested and 28 of them were selected and installed in the fully assembled modulator cabinet this quarter.
